## REMEDIAL ACTION REPORT

**216 Paterson Plank Road Site  
Operable Unit No. 2 (OU-2) Remedy  
Carlstadt, Bergen County, New Jersey**

**Project No. 943-6222.001**

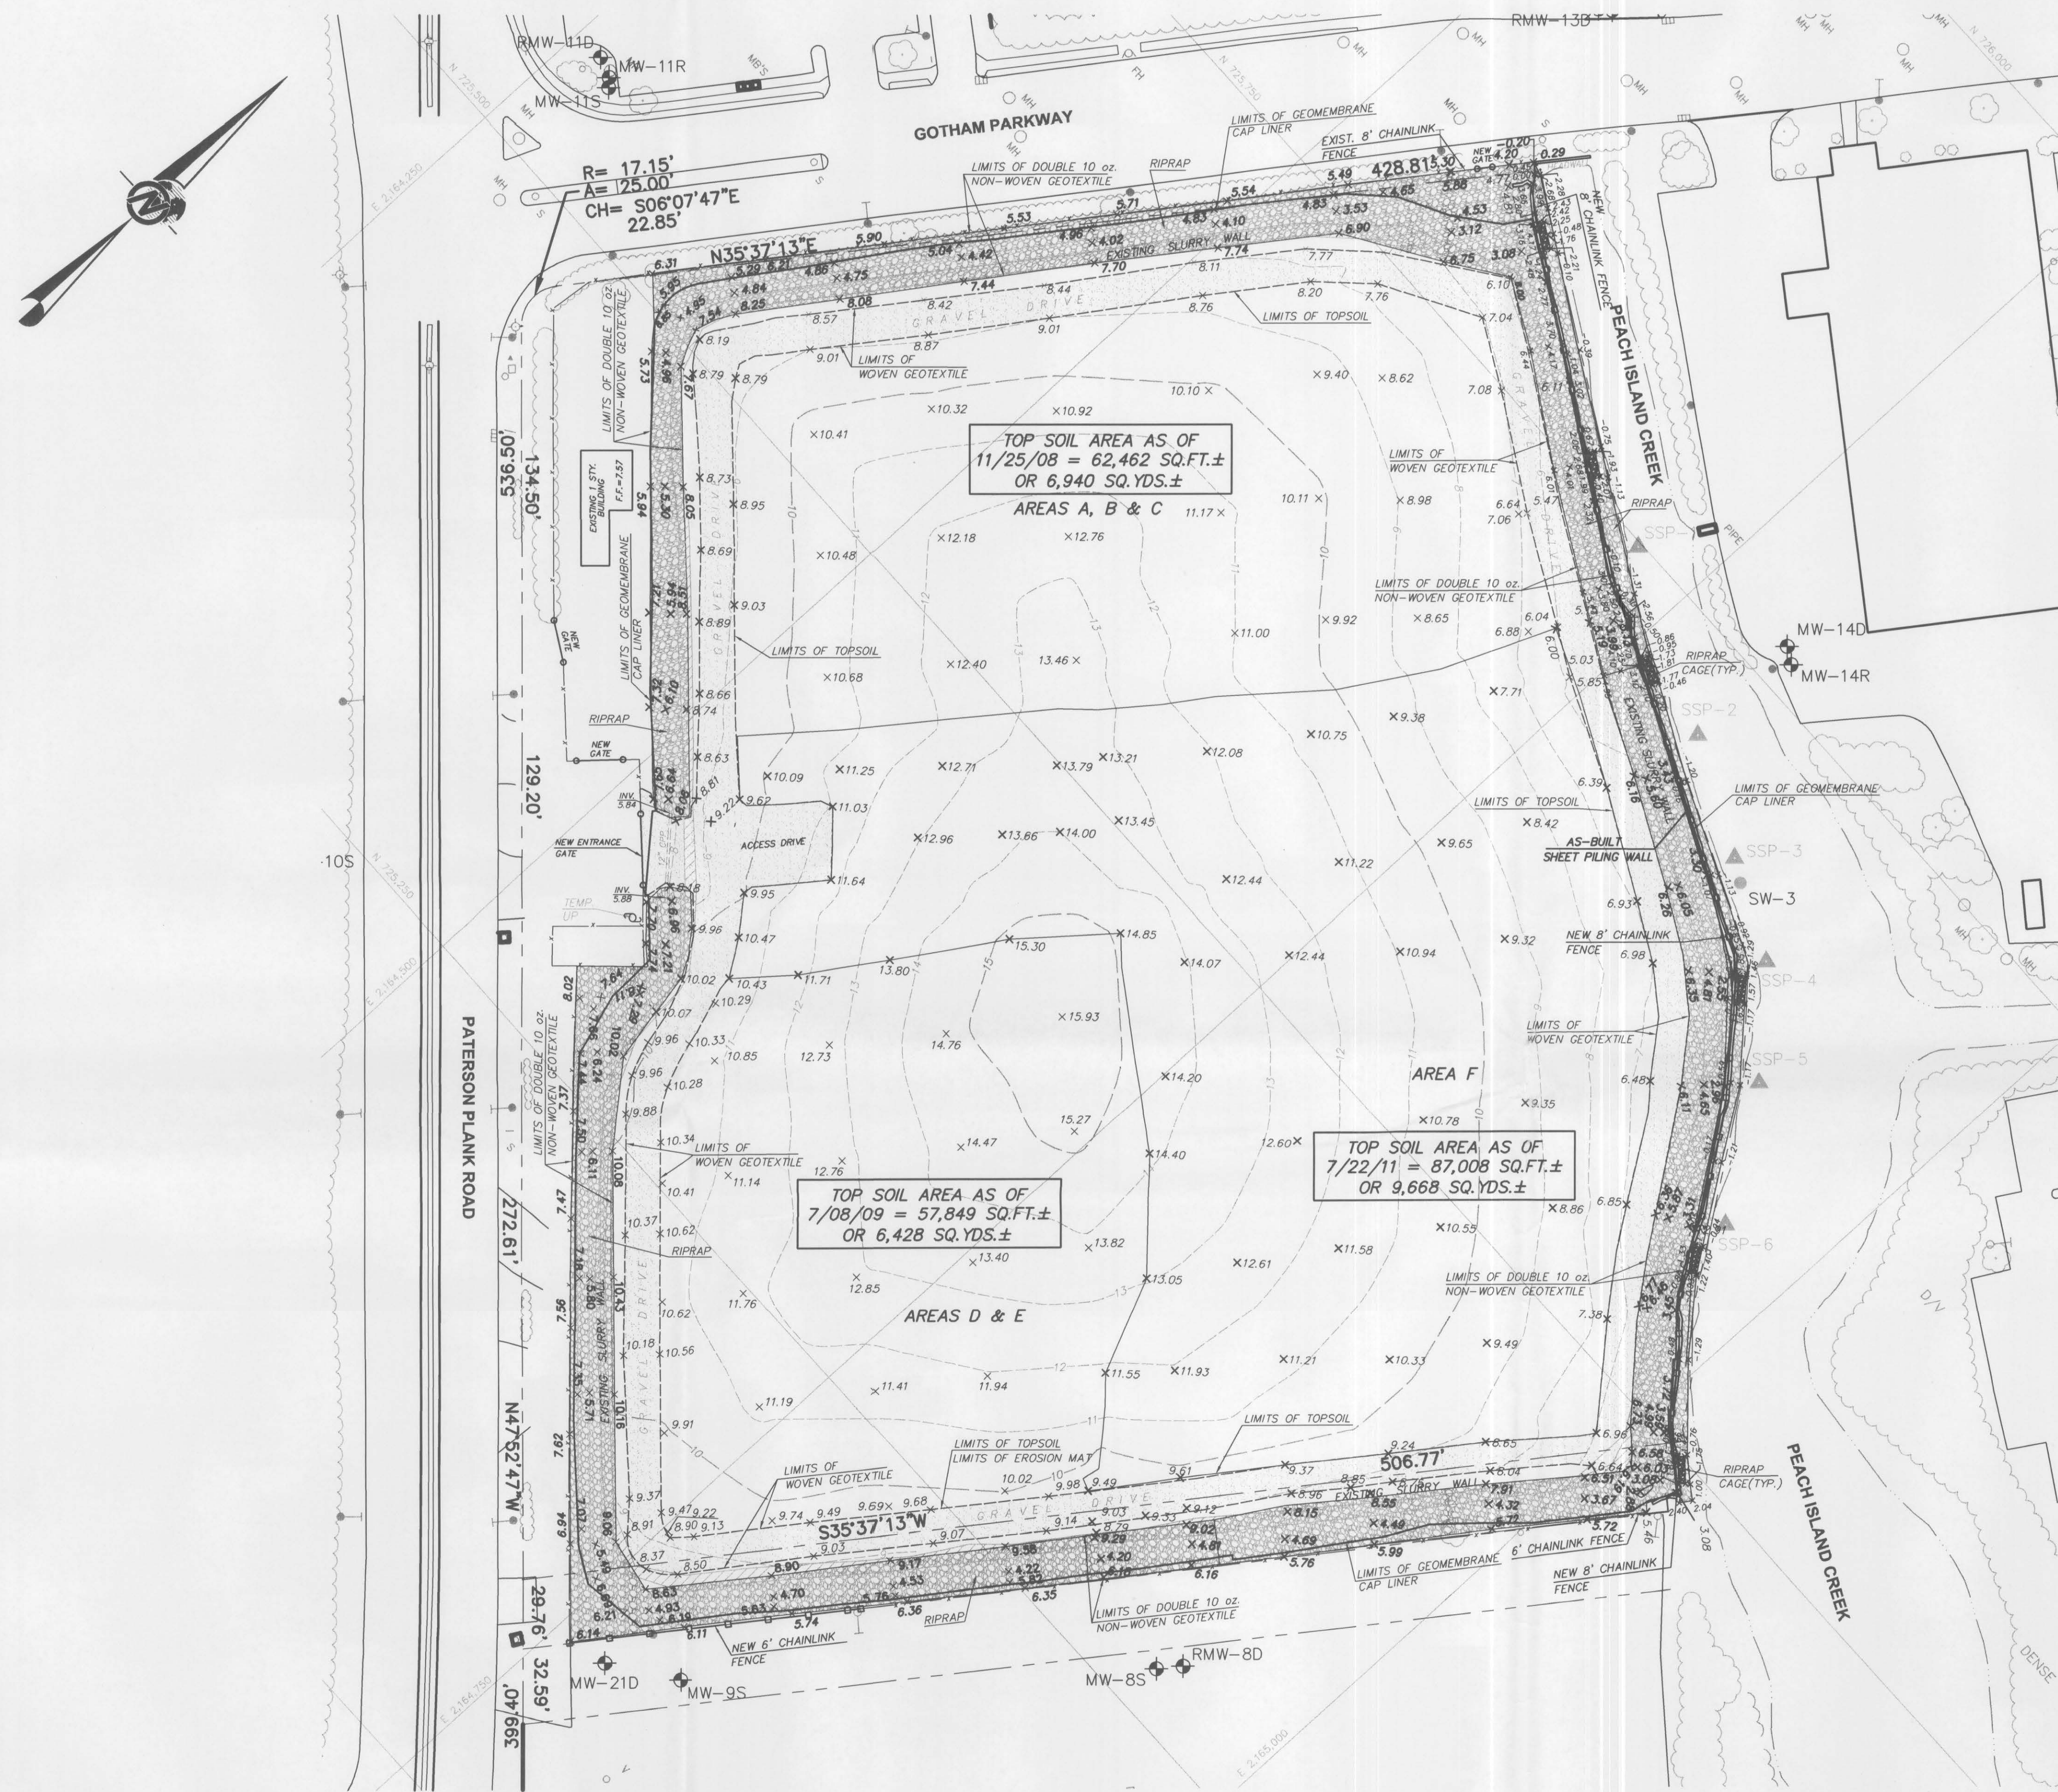
**AS-BUILT FINAL SITE CONDITION SURVEY**  
FOR  
**ENTACT ENVIRONMENTAL SERVICES**  
216 PATERSON PLANK ROAD SUPERFUND SITE  
OPERABLE UNIT NO.2 (OU-2) FINAL REMEDY  
LOTS 1-5, BLOCK 124  
BOROUGH OF CARLSTADT BERGEN COUNTY NEW JERSEY

LINEAR FOOTAGE OF NEW FENCE = 792± L.F.  
RIP RAP VOLUME FOR CREEK AREA OUTSIDE OF SHEET PILING WALL = 340± CU.YDS/ AS OF 1/14/09

LEGEND	
X 12.40	AS-BUILT TOPSOIL ELEVATION
X 8.39	AS-BUILT EDGE OF GRAVEL ELEVATION
X 6.12	AS-BUILT RIP RAP
—	NEW FENCE LINE

- 4.) NEW FENCE, PERIMETER DRAINAGE CHANNEL, ACCESS ROAD, GEOMEMBRANE AND MAINTENANCE BUILDING LOCATIONS/LIMITS TAKEN FROM DIGITAL CAD FILE RBSU008761.DWG, FIGURE 7 OF 7, ENTITLED "AS-BUILT FINAL SITE CONDITION SURVEY," PREPARED BY MASER CONSULTING P.A., DATED AUGUST 12, 2011.

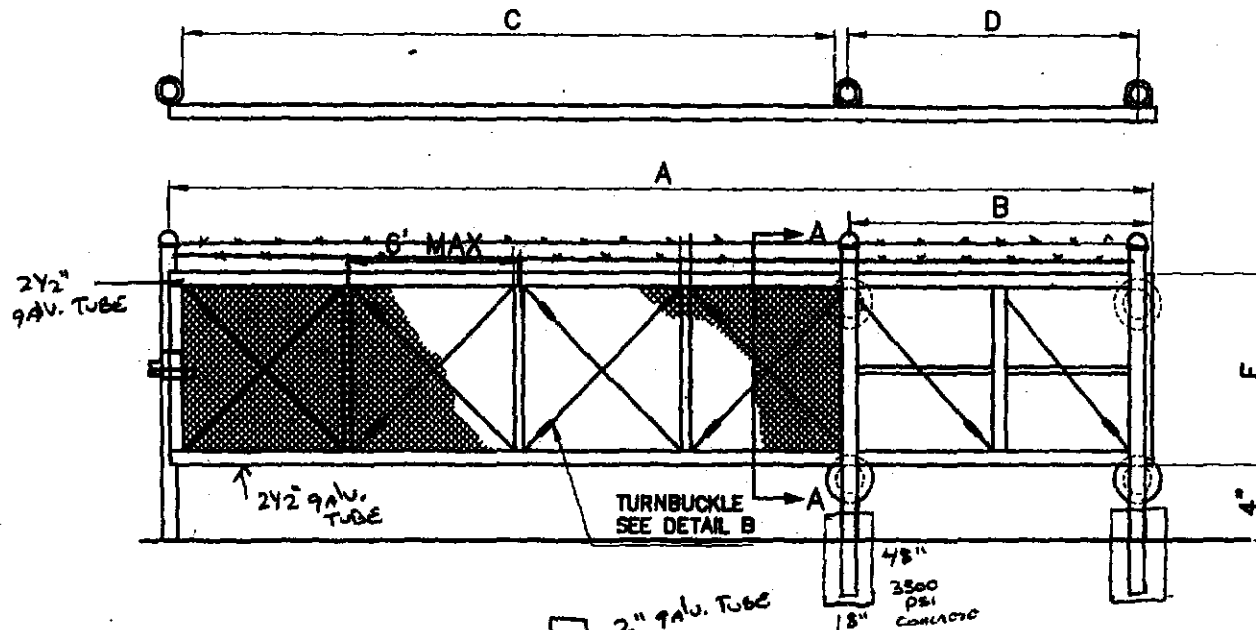
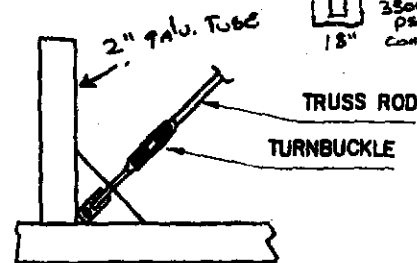
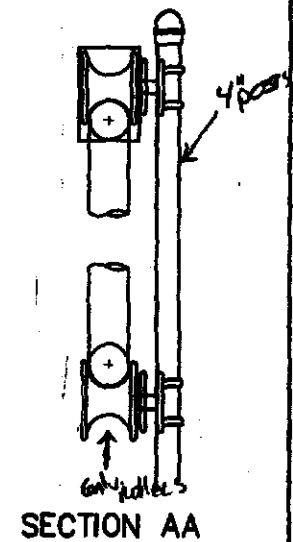
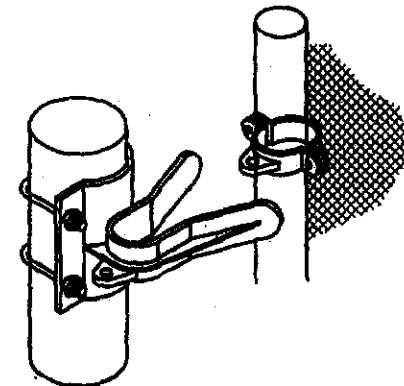
# CANTILEVER GATE

USING 4" O.D POST 2Y2" HORIZONTAL RAIL AND 2" VERTICAL RAIL

DETAIL - B

ROLLING GATE LATCH

ITEM	DESCRIPTION	SIZES	DATE	SCALE	TITLE
A	OVERALL GATE WIDTH	45'		NTS	CANTILEVER GATE
B	HALF OF "C" DIMENSION	15'			
C	GATE OPENING	31'			
D	12" LESS THEN "B"	15'			
E	GATE HEIGHT	84" (6+1)			
			DRAWN BY	DRAWING NO.	CANTILEVER WITH ROLLER
